# Ewen Park

## EWEN PARK STAIRCASE RECONSTRUCTION

PDC

November 7, 2022

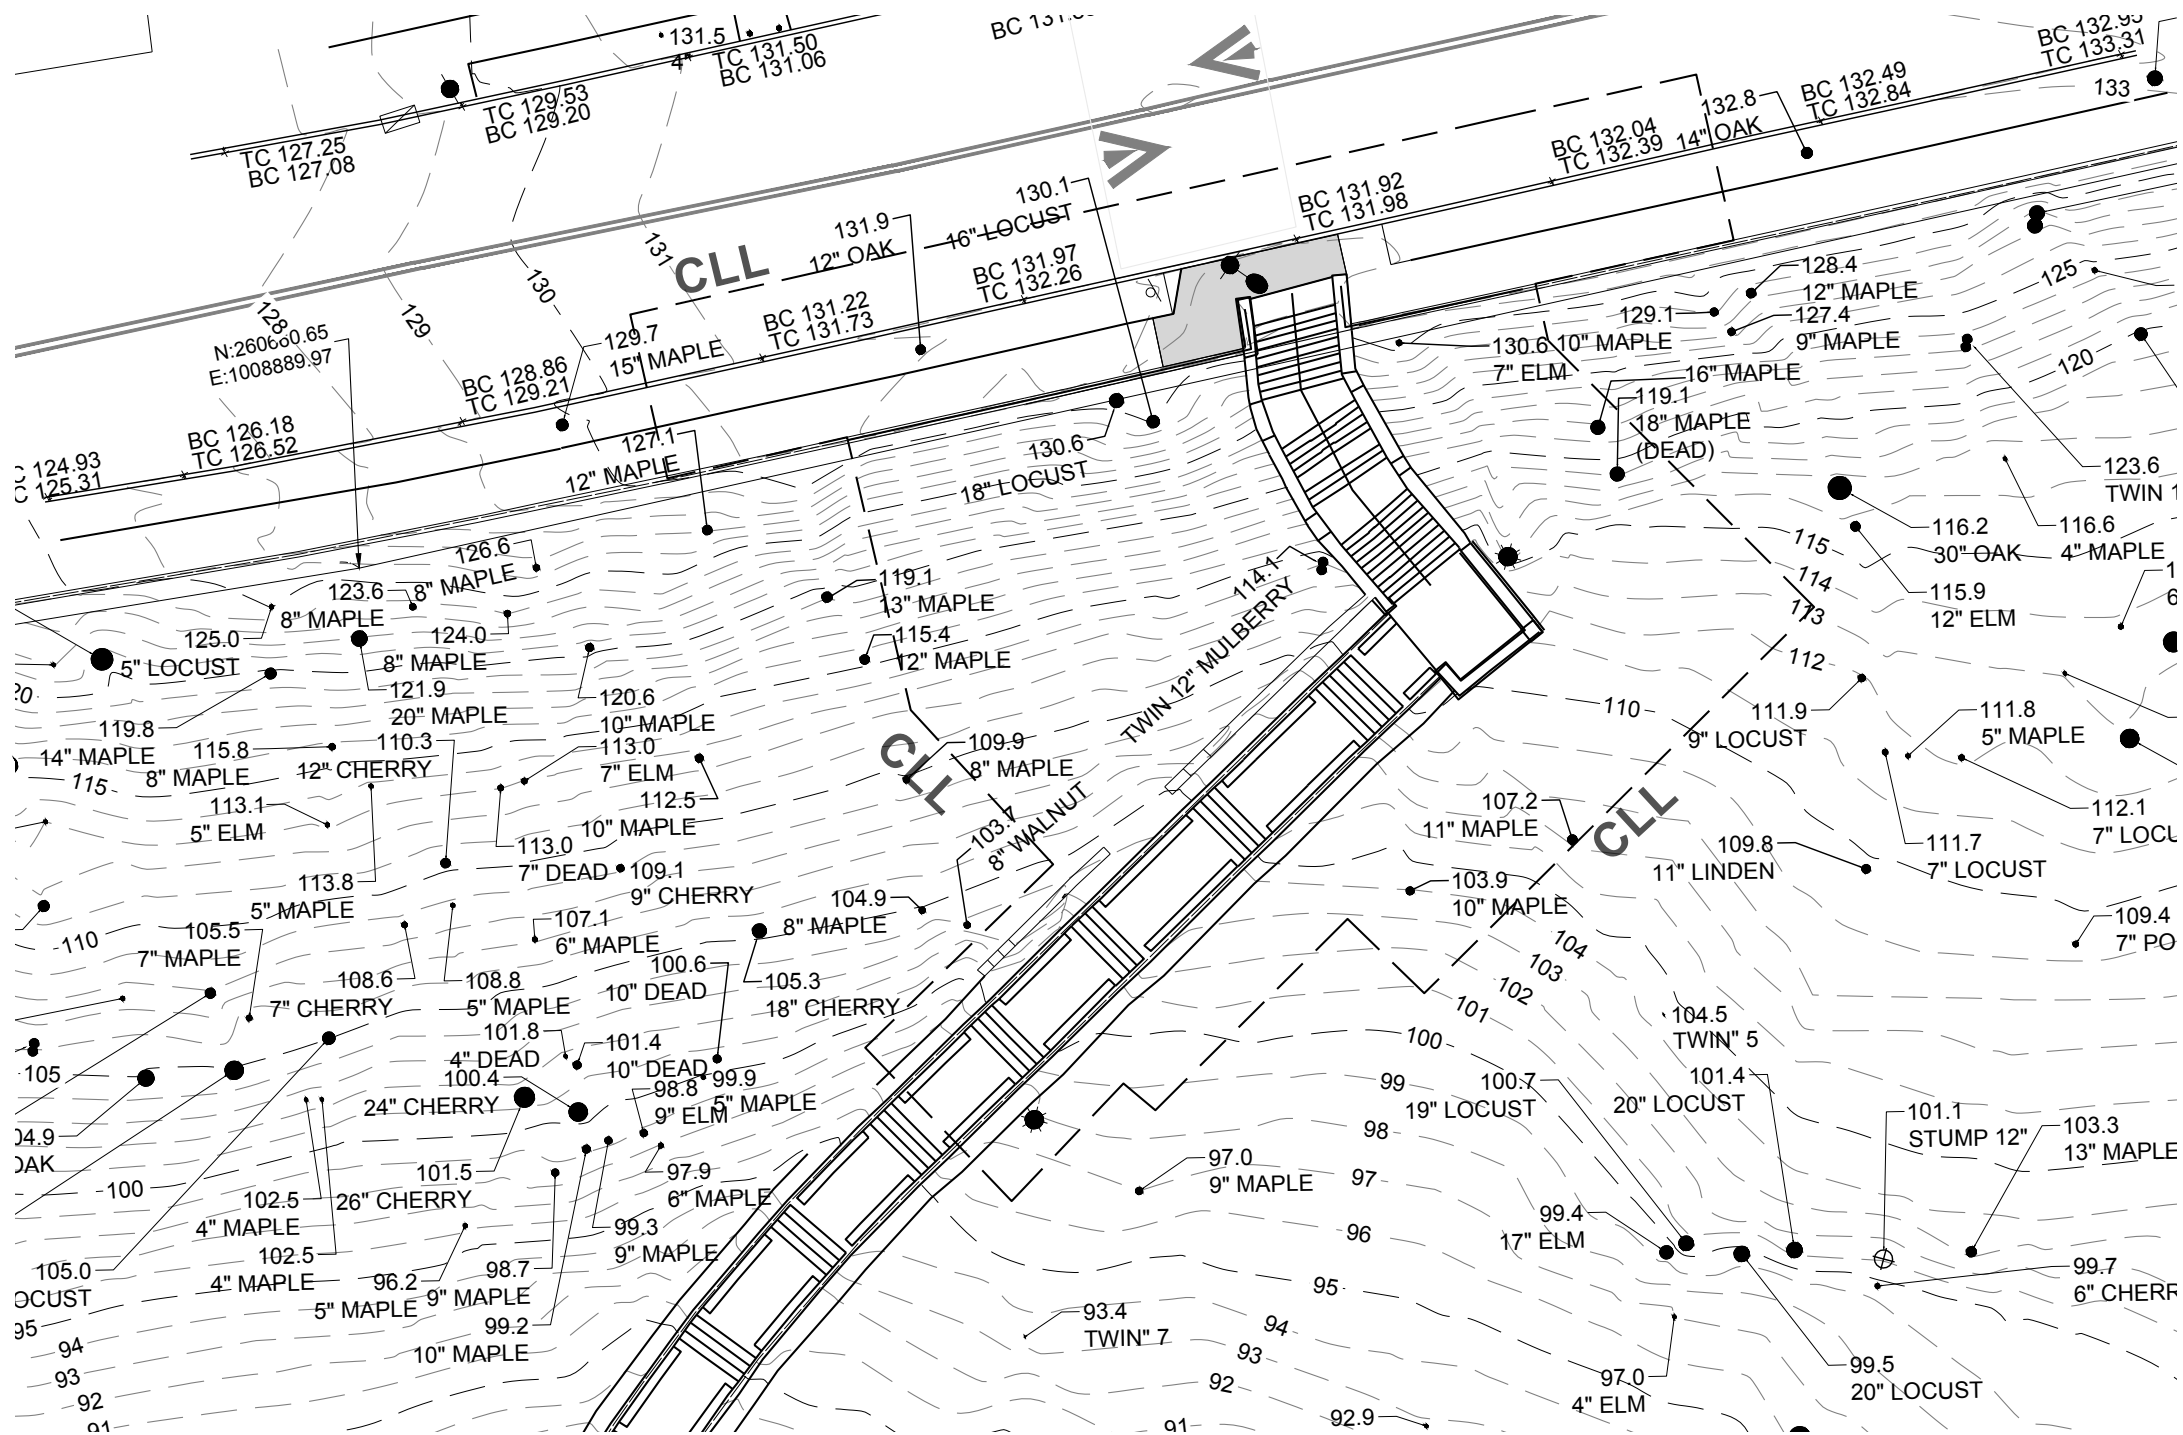
## Ewen Park | Existing Staircase Conditions

### Staircase Safety Concerns:

- Staircase encroachment into the sidewalk; poor pedestrian circulation
- Risers, treads and railings are not code compliant; very poor condition, uneven surfaces
- Poor visibility; Inadequate lighting
- Steep slopes- erosion, difficult site access
- Concentrated drainage flow down full length of stairway
- Stepped walkway railings are not code compliant

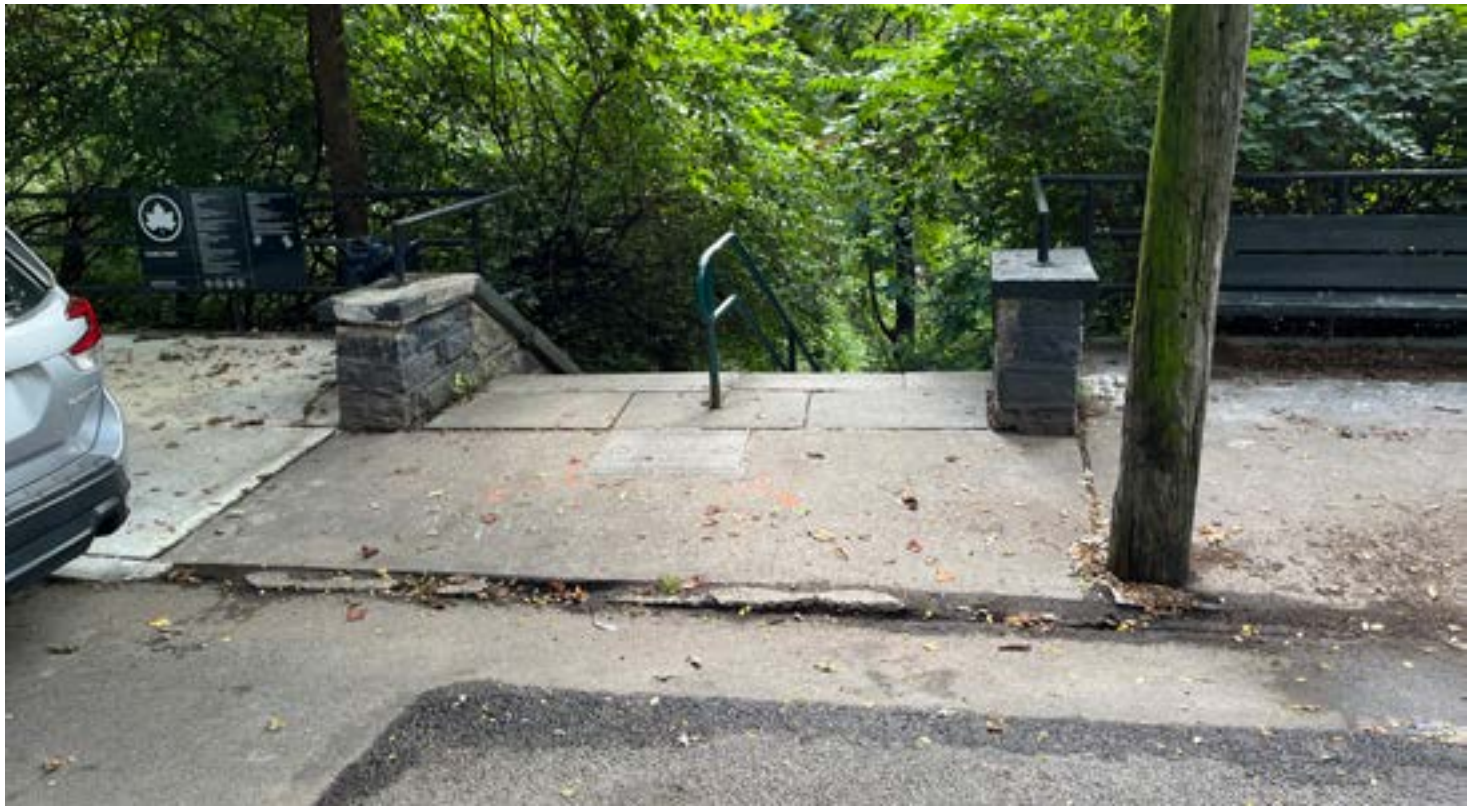
1 - Johnson Ave. Entry

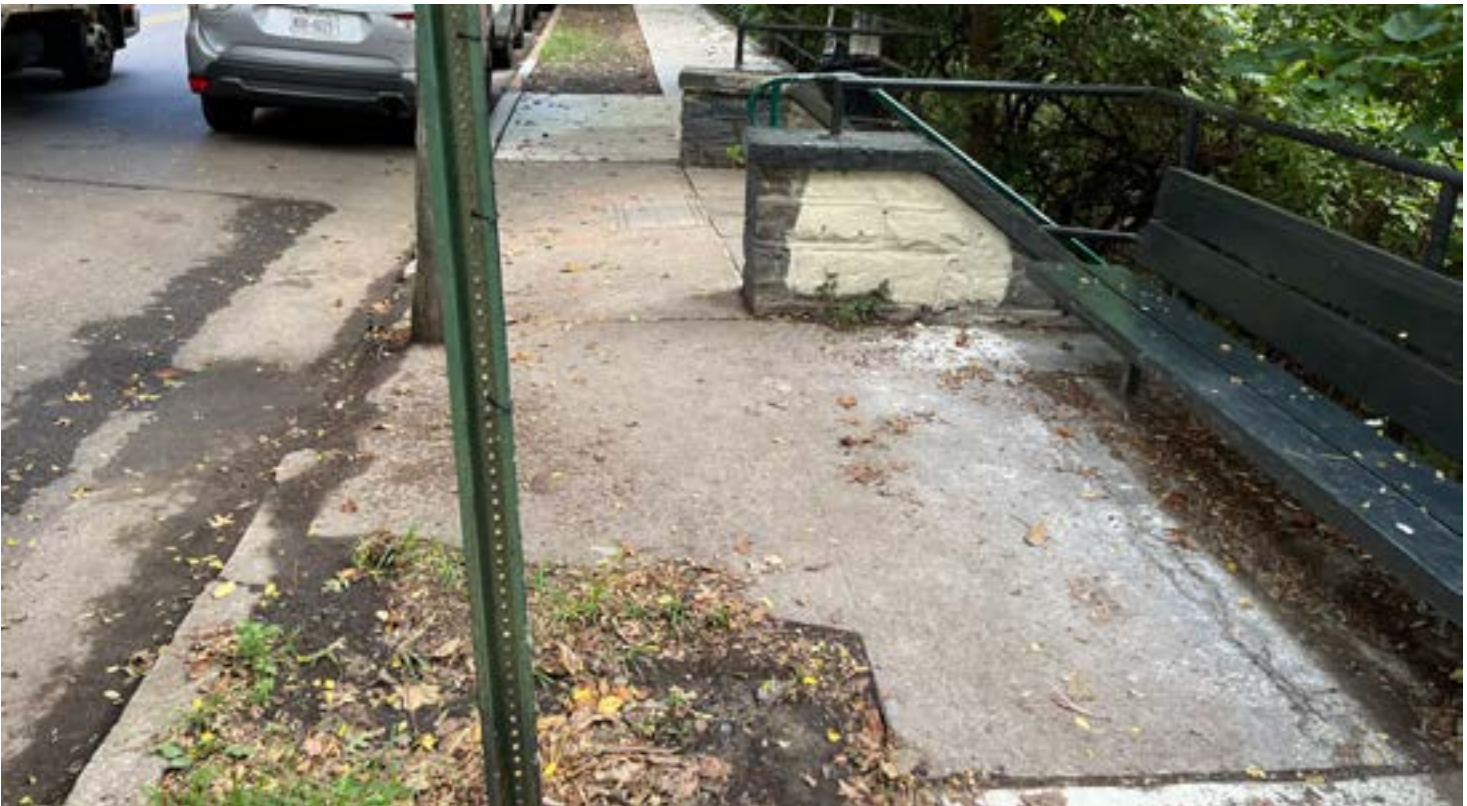
2 - Johnson Ave. Entry looking north

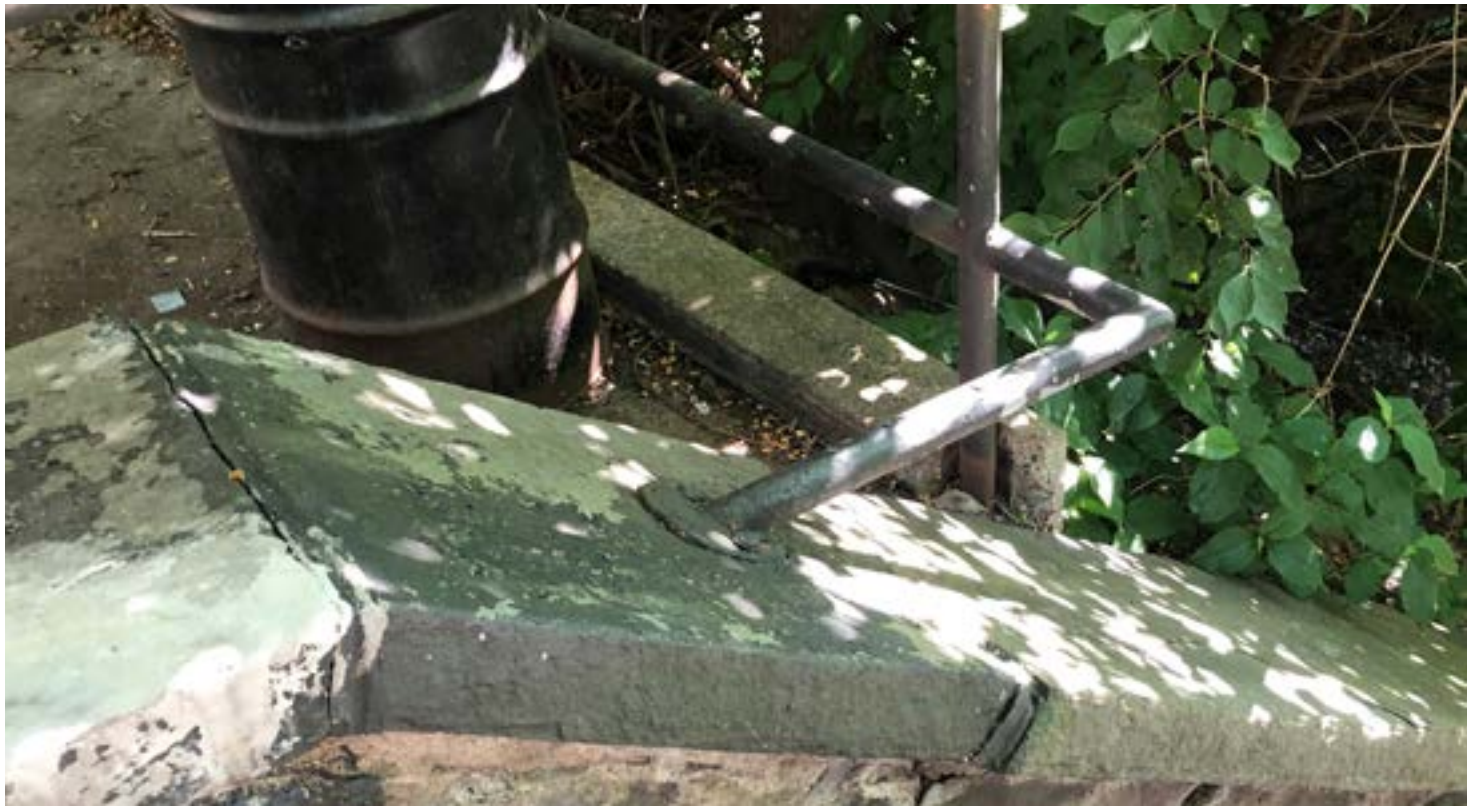
1 - Looking at entry cheekwall and sidewalk railing and curb wall

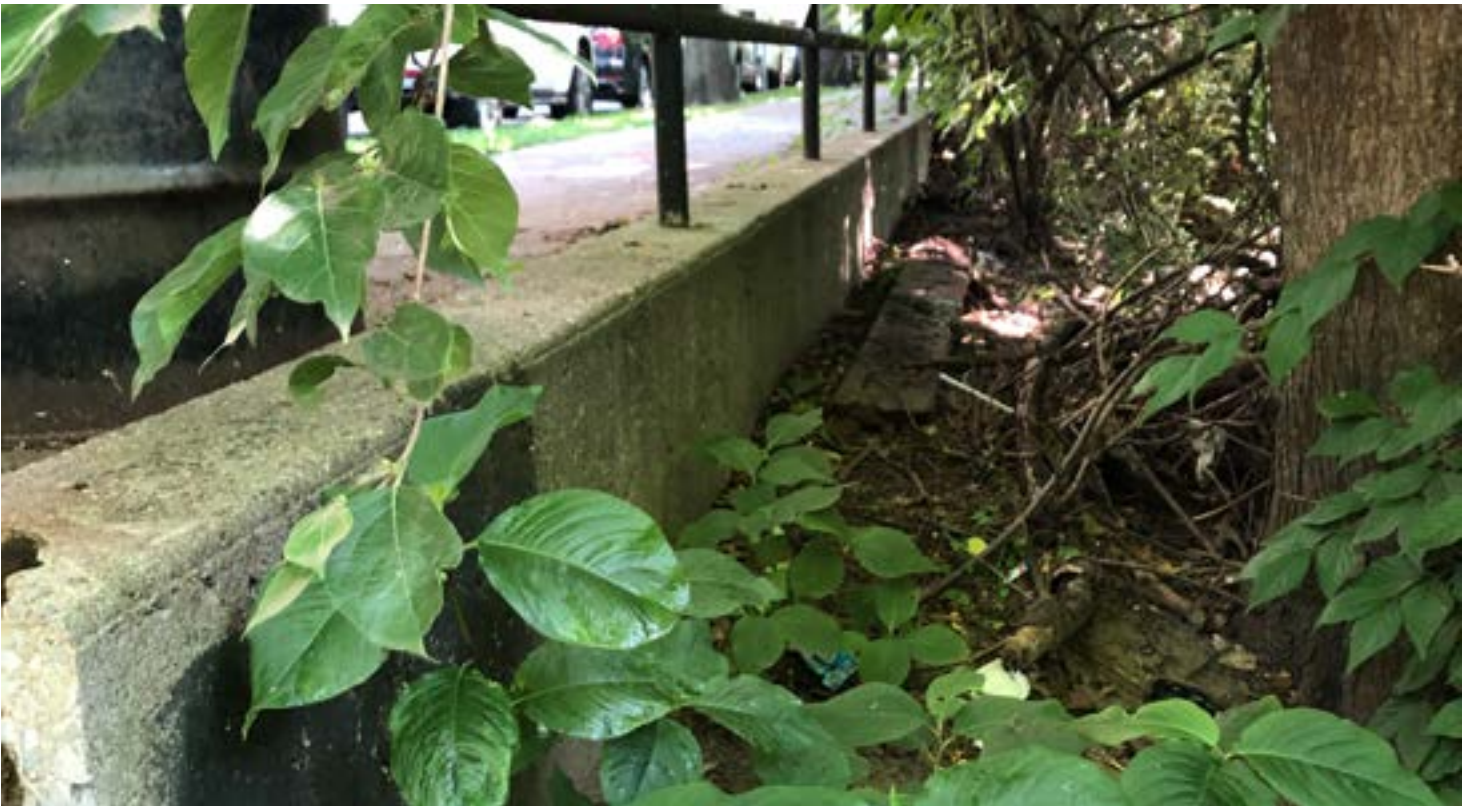
2 - Looking north along Johnson Ave at railing and curb wall

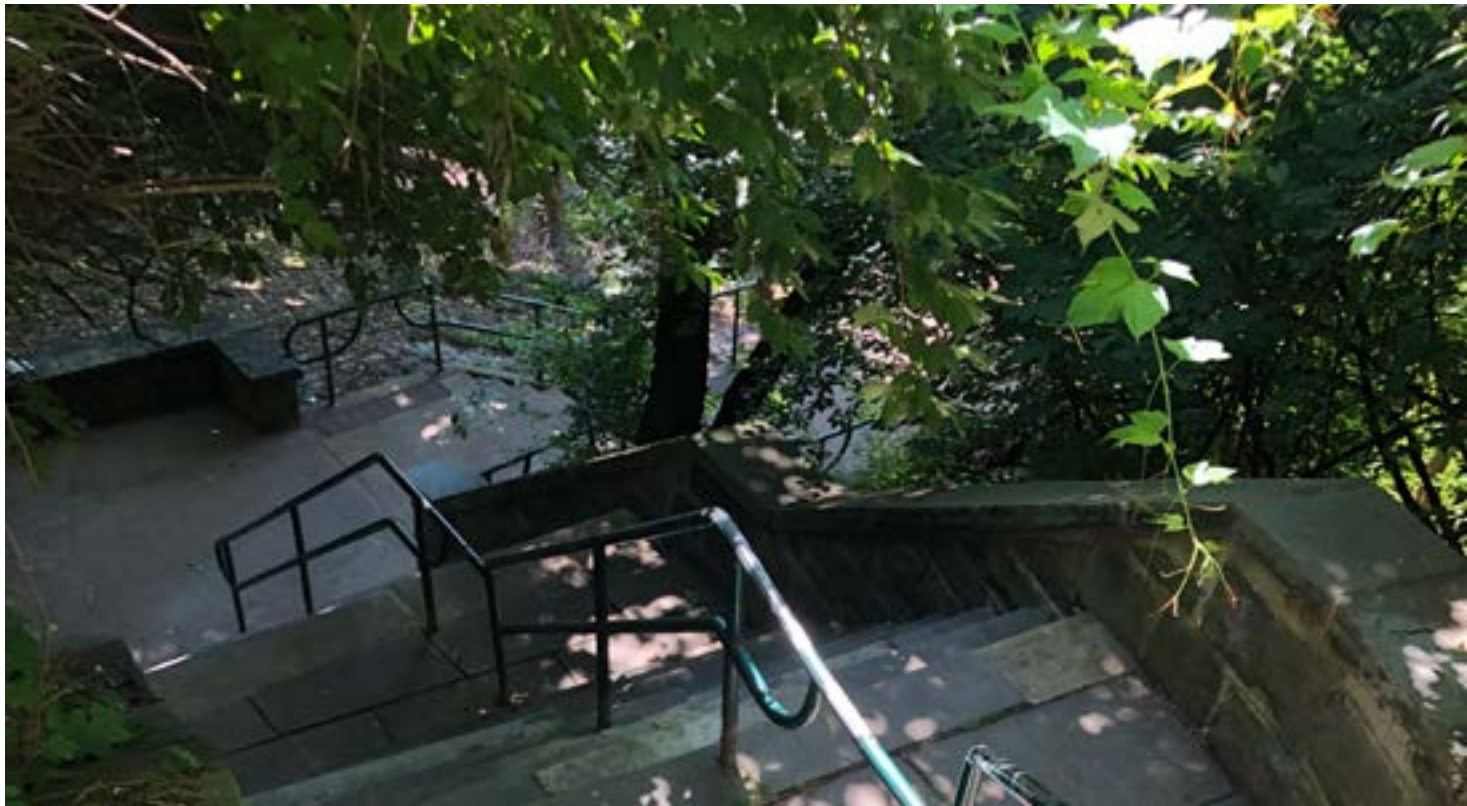
1 - Looking down stair

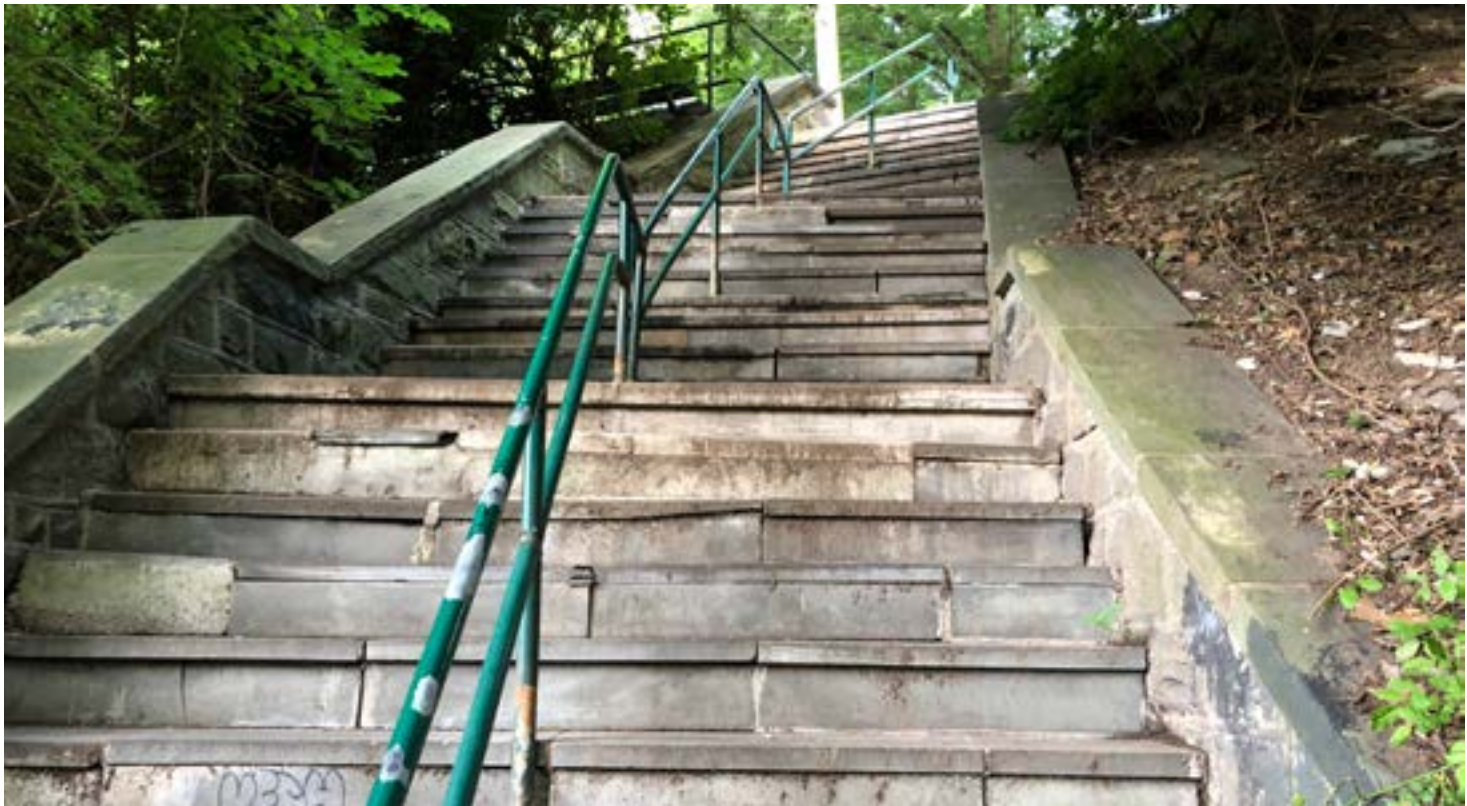
2 - Looking up stairway

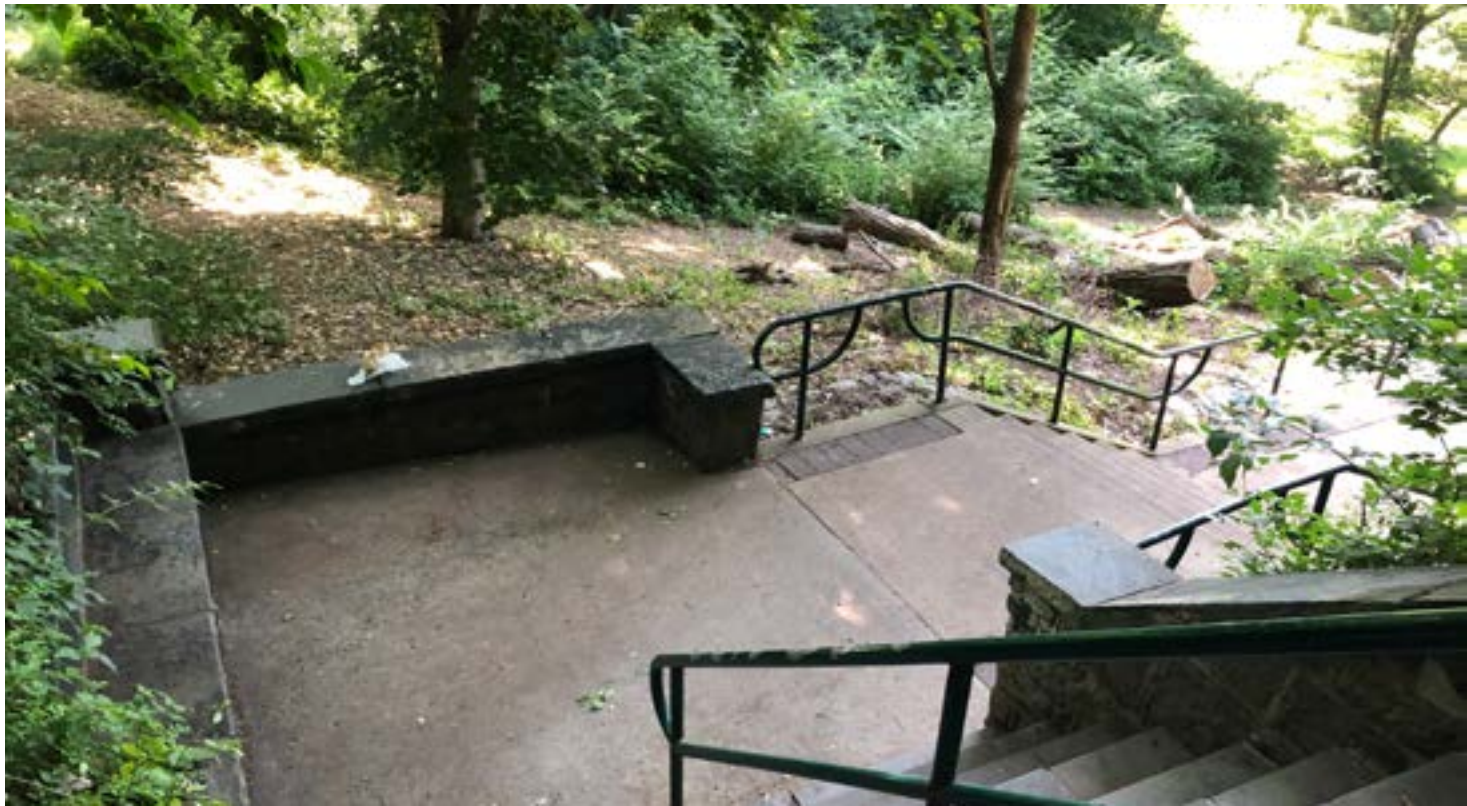
1 - Looking down at bottom landing entry

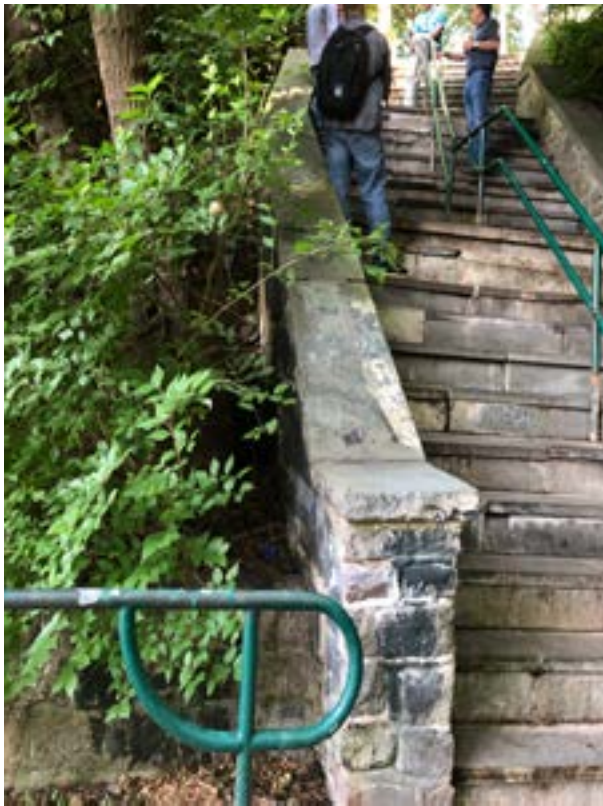
2 - Landing details

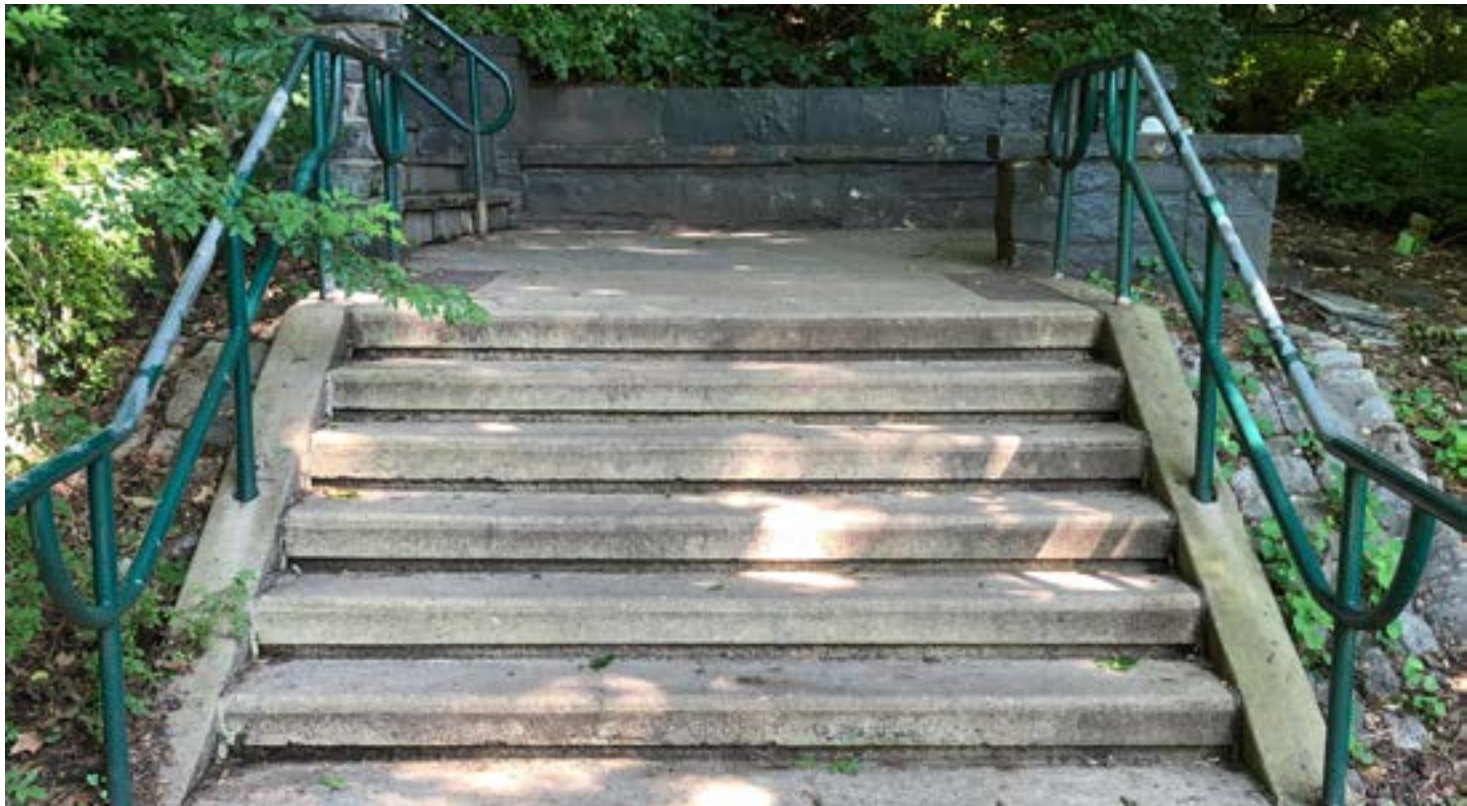
1 - Looking at lower entry landing at stepped walkway

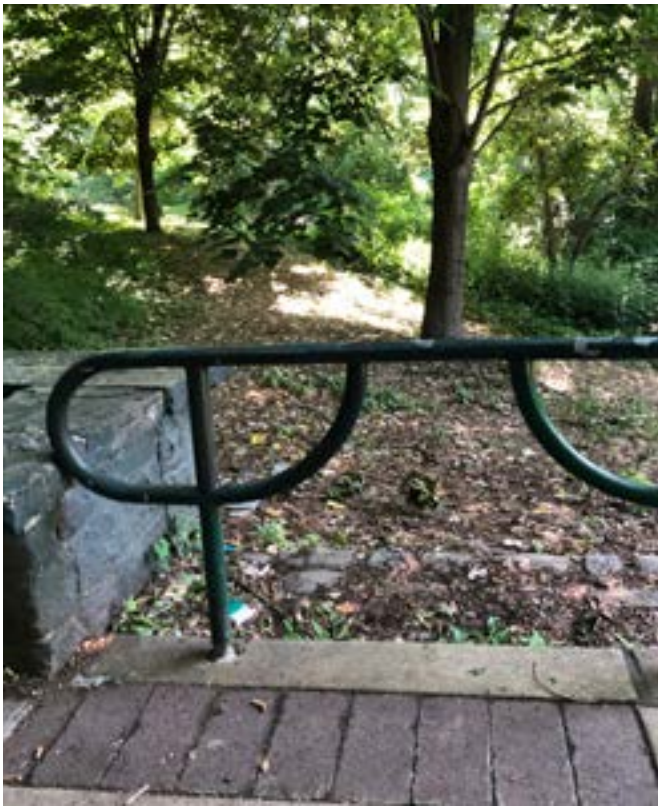
2 - Looking at bottom landing, southeast corner condition

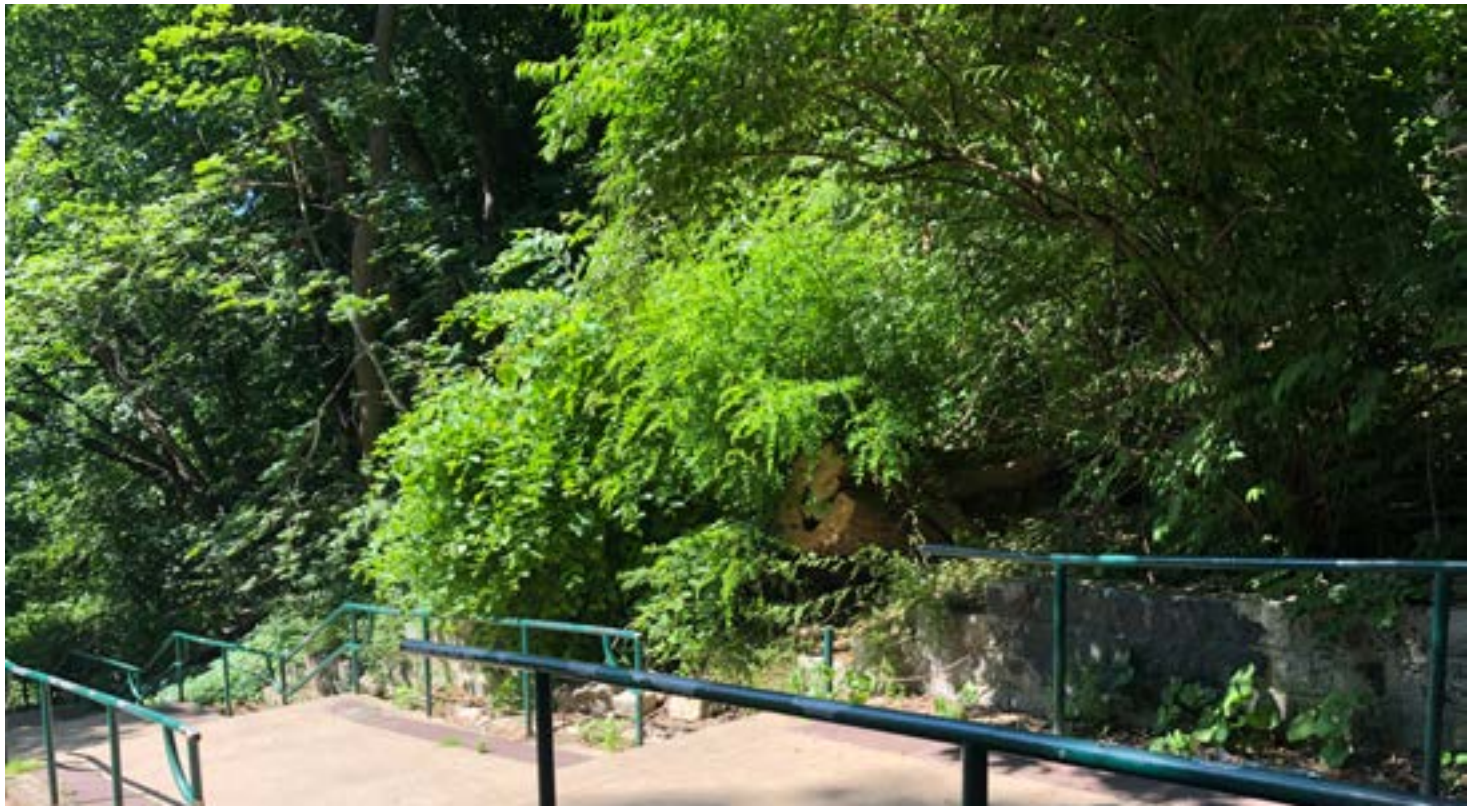
1 - Looking southwest at slope along stepped walkway

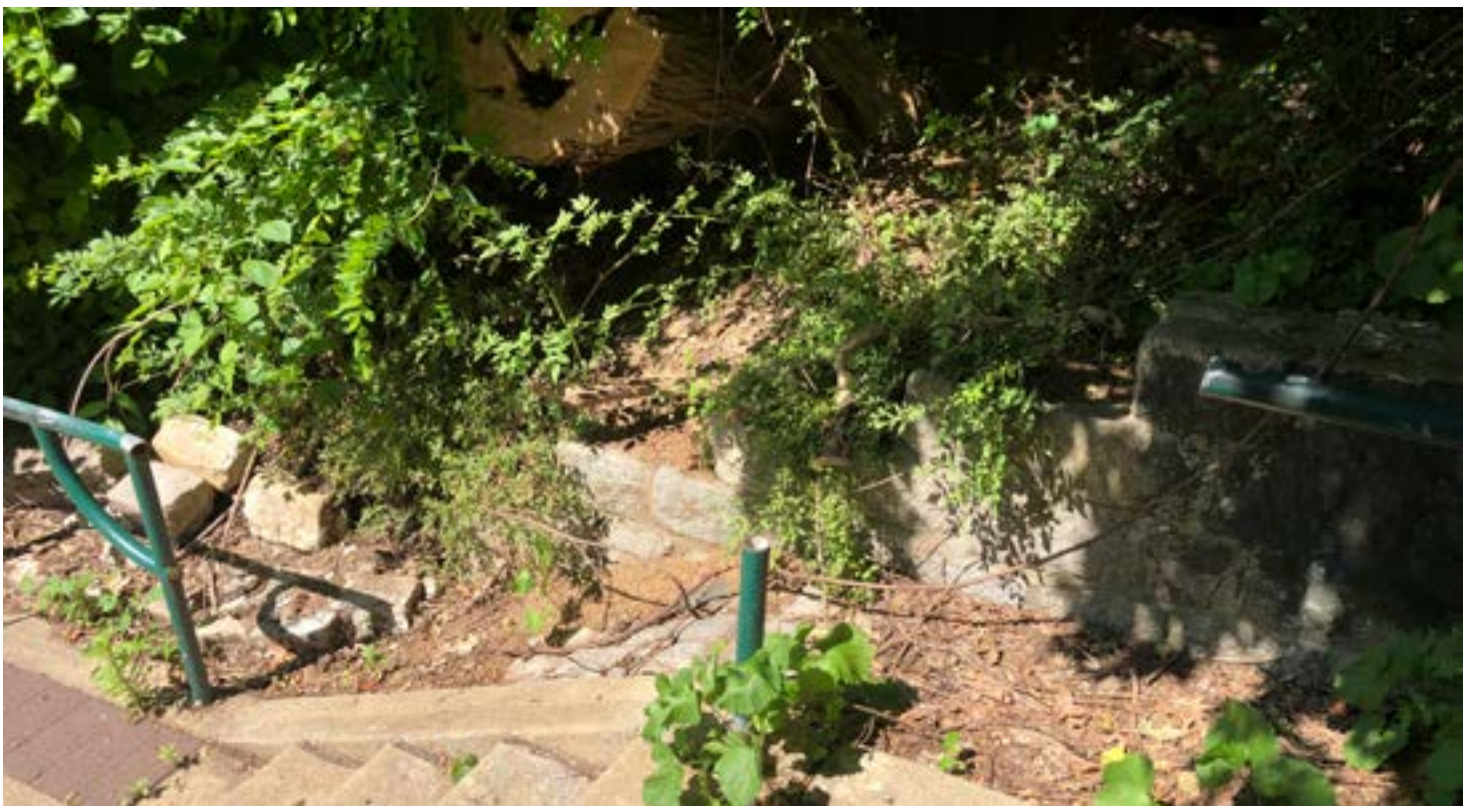
2 - Retaining wall at slope base

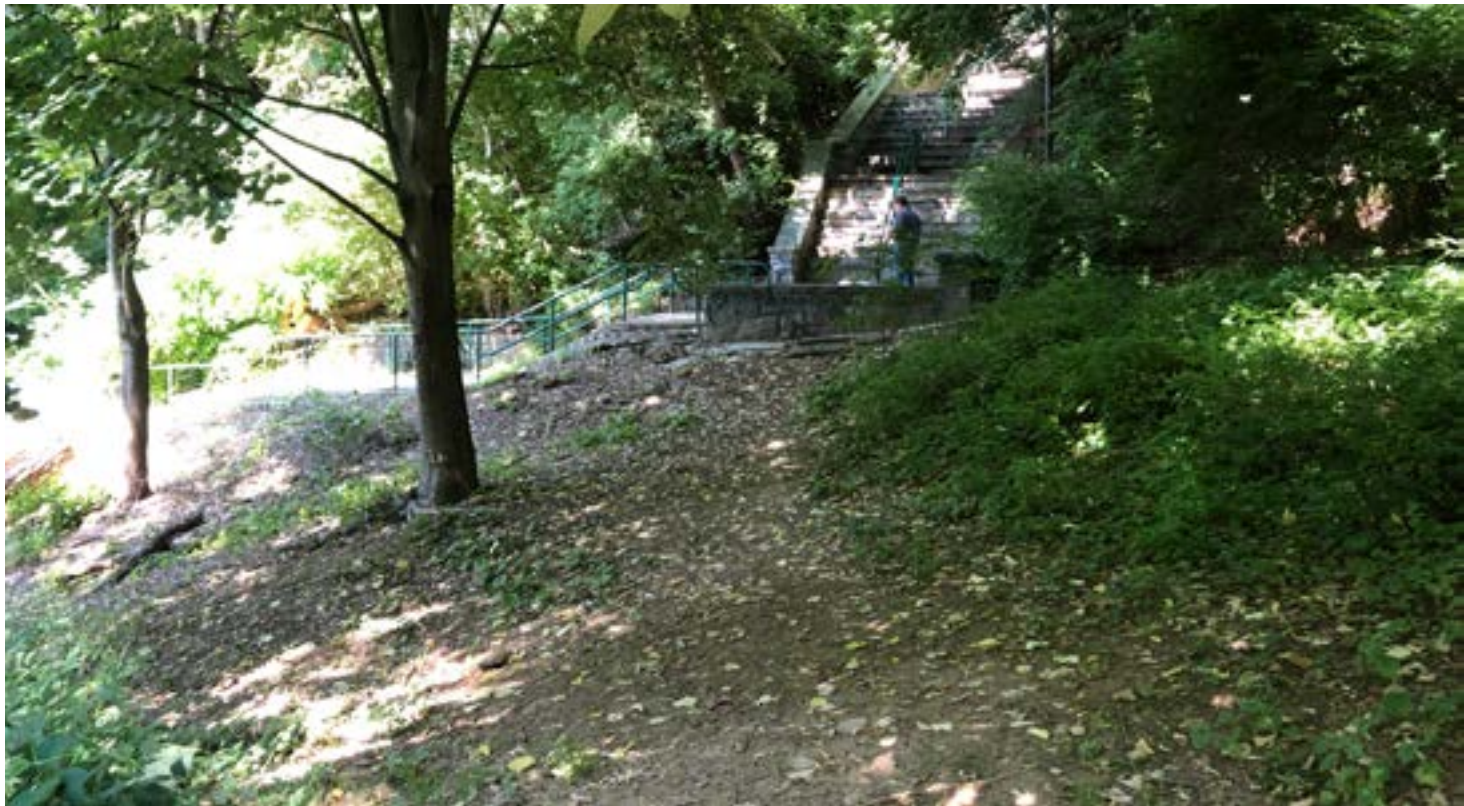
1 - Looking west at stairway from adjacent area linking to Walk

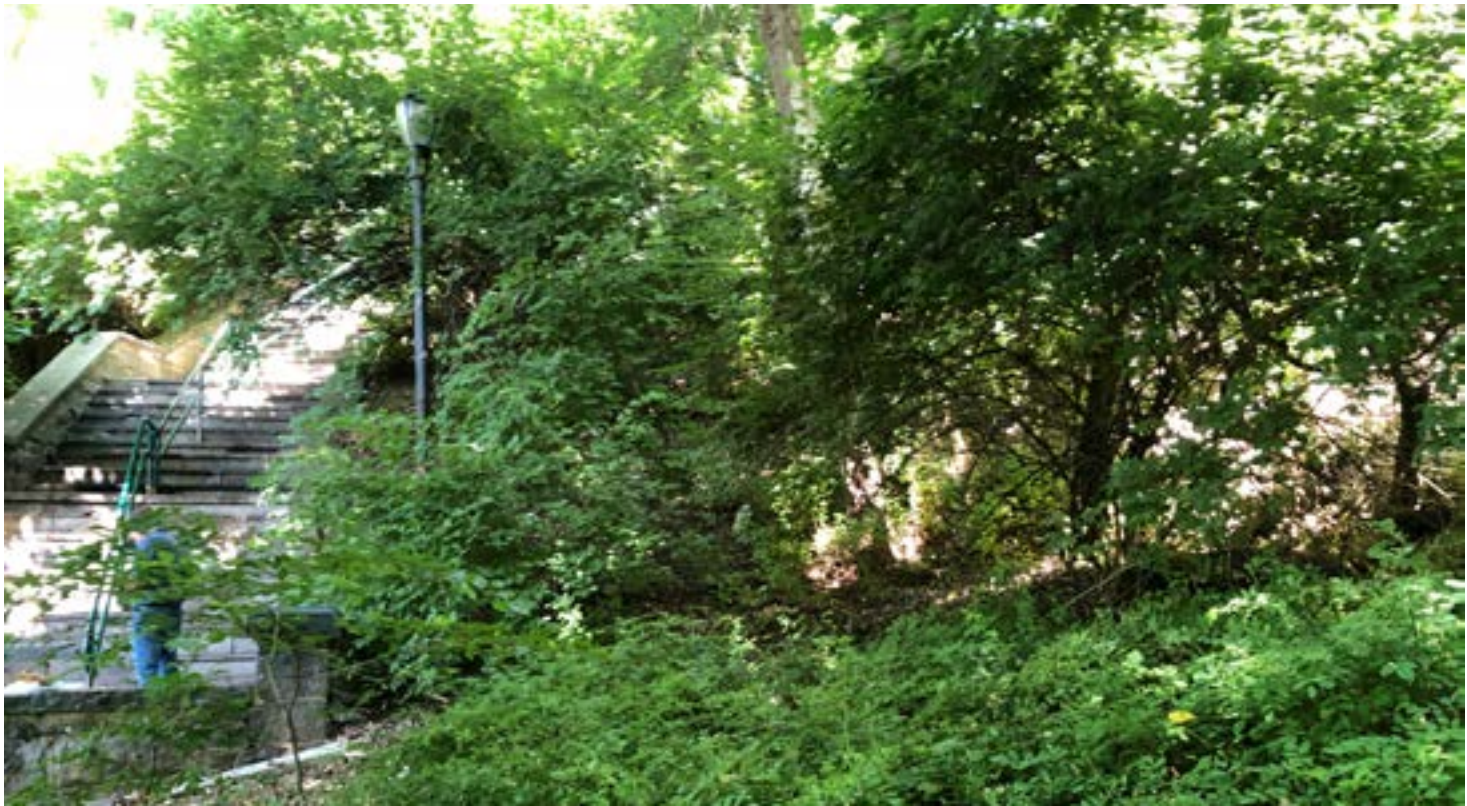
2 - Looking west towards slope north of stairway
