**Minutes of the Parks & Recreation Committee Meeting  
Bronx Community Board 8  
Wednesday, April 22, 2026 at 7:00pm  
Board Office – 5676 Riverdale Ave, Suite 100, Bronx, NY 10471**

# **Master Planning Study For Van Cortlandt Park Stadium Building and The Surrounding Facilities**

Broadway and Van Cortlandt Park South, Bronx, NY 10471

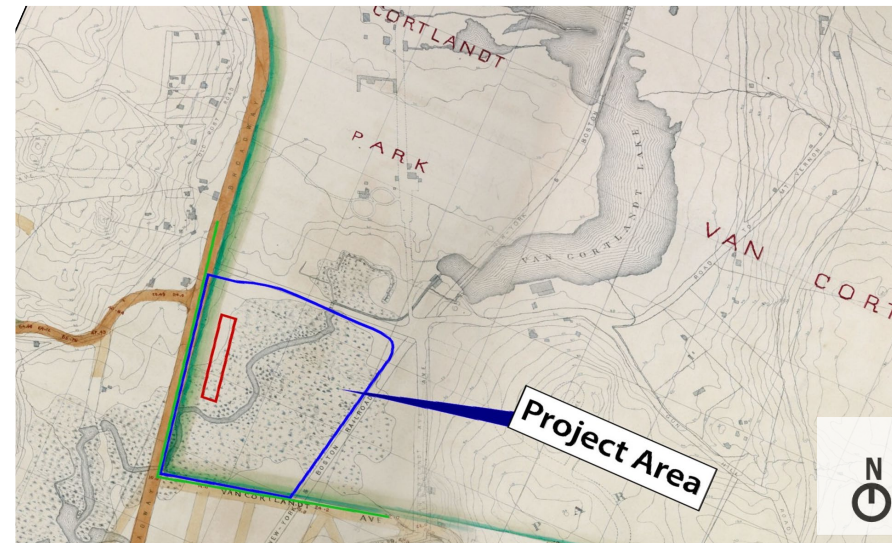
Topographical map dated 1873

**Key Takeaway:** The site was historically a wetland and did not have any inhabitants until Van Cortlandt Park was created. The archaeological sensitivity of the project area is considered low.

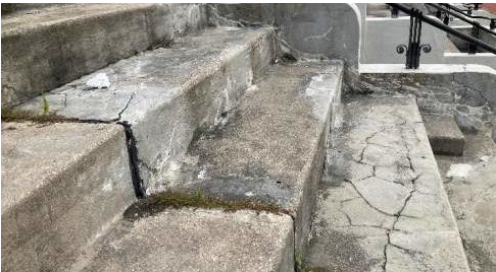
Bleachers

- 1 **The stadium building is in poor structural condition.** Most of the observed deterioration could be **attributed to water infiltration and to large temperature differentials** experienced by the building.
- 2 **At many locations the previous repairs failed, and new cracks formed around the mortar or concrete infill or across the infill.** Cracks with existing caulking infill and cracks with tape and cementitious repair appear to be deteriorating.
- 3 The **expansion joints have not been maintained** and the existing backing material and sealant have deteriorated.
- 4 **Cracks, rust staining and concrete spalls** with exposed rebar were observed underneath the bleachers,
- 5 **Significant efflorescence and stalactite formation** were observed in the sloping beams with expansion joints.

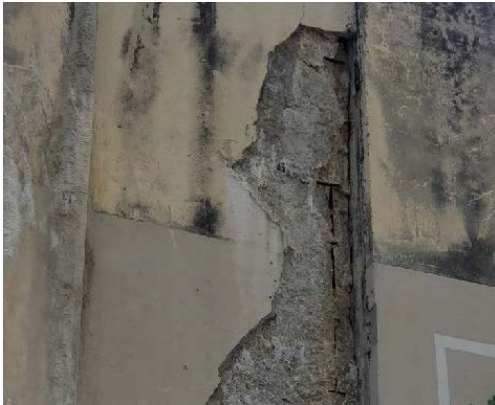
West Wall Concrete Spalls

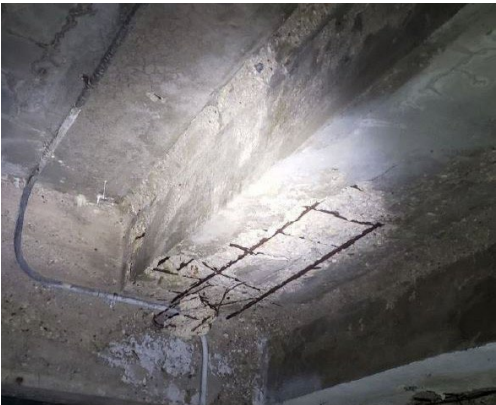
Underside of Bleachers

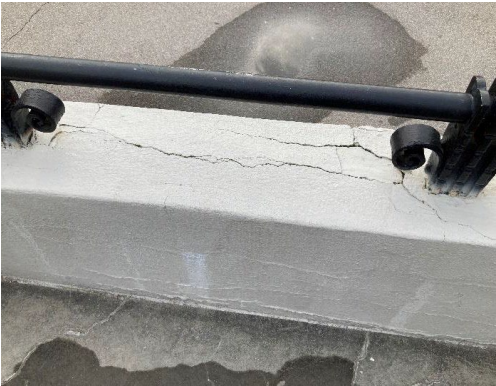
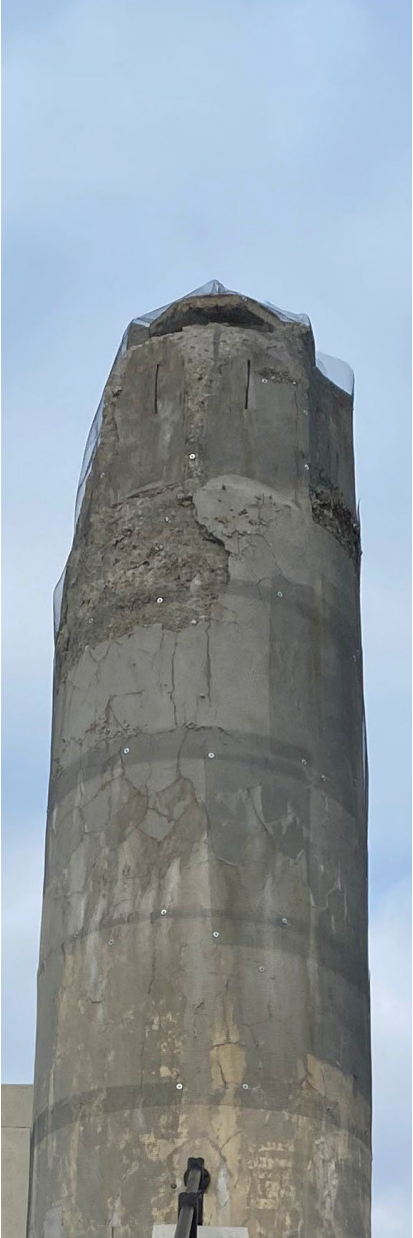
Damaged Towers

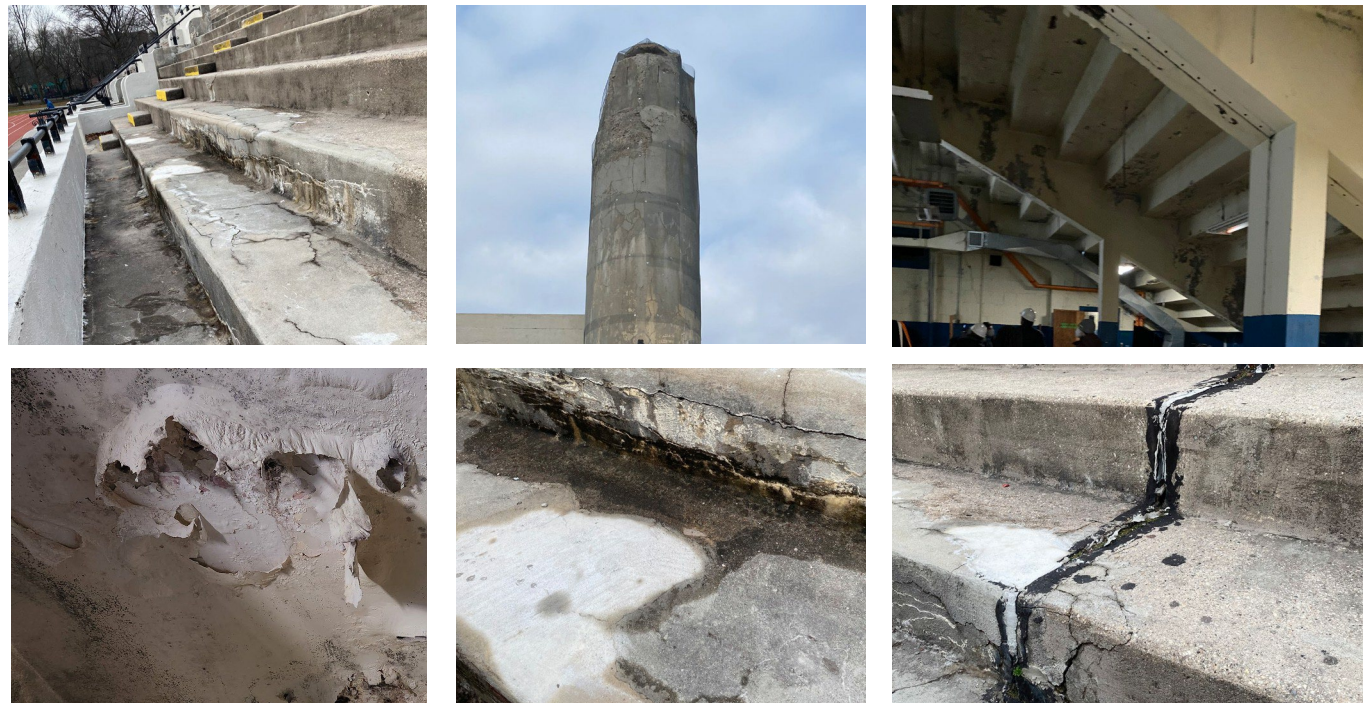
### 1 IRREPARABLE STRUCTURAL ELEMENTS

Keeping existing beams, columns, walls and foundation is not feasible in the long-term, and will require complete demolition and rebuilding.

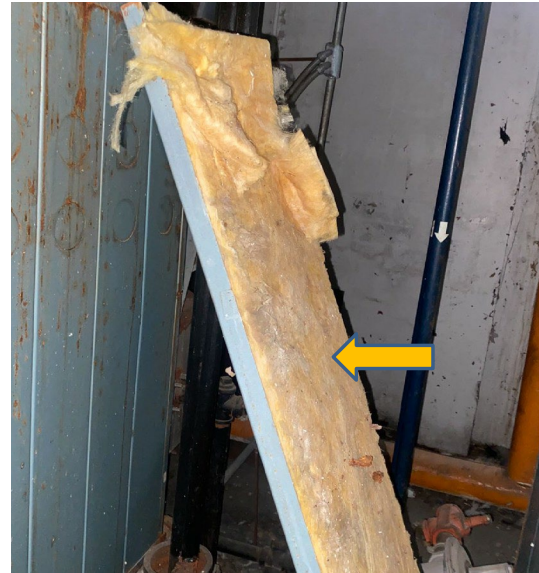
Boiler Cover Insulation

- Asbestos (Sampled and Presumed)
- Lead Based Paint (>0.5%)
- PCBs (>50 ppm)
- Mold

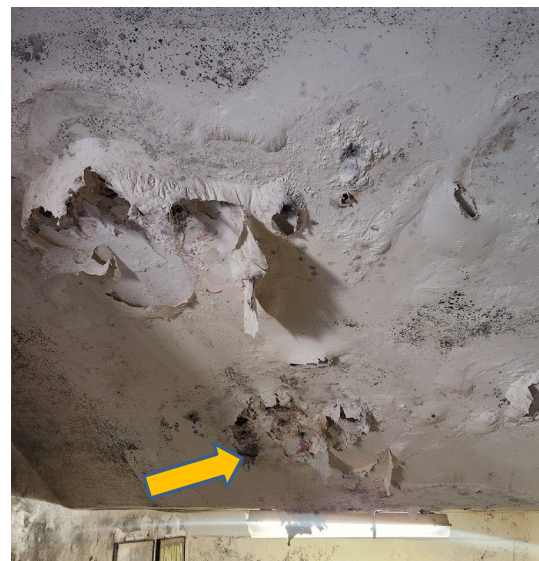
Mold on Interior Walls

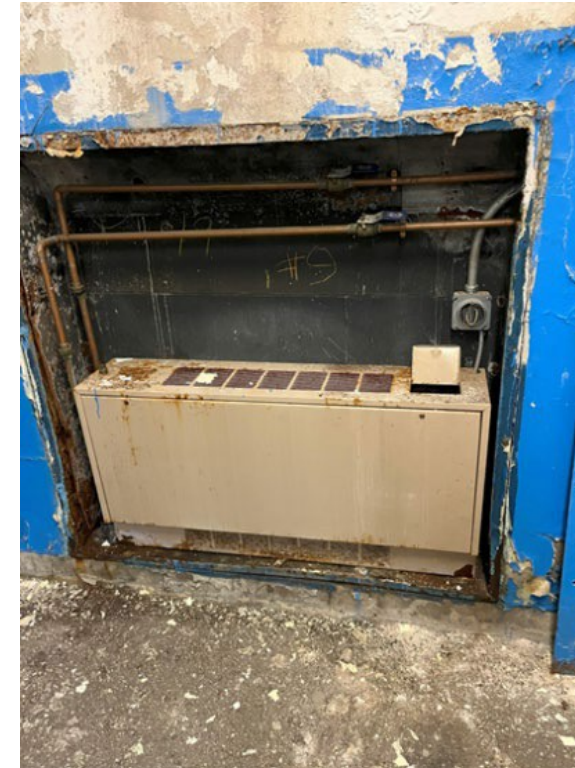
Typical Existing Fan Coil

Most equipment and utilities are original, in **poor condition, non-operational, and not code compliant**. The report evaluates three potential approaches: Option 1 (reconstruction of the existing building), which is determined to be not viable due to the extensive scope required; and Options 2 and 3 (new construction), which are recommended as they can meet future building needs and align with NYC's sustainability requirements.

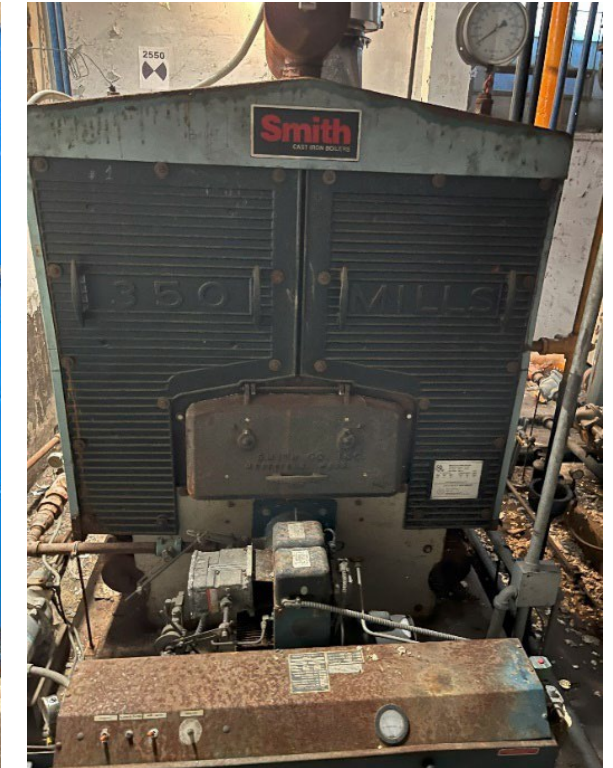
Existing Boiler

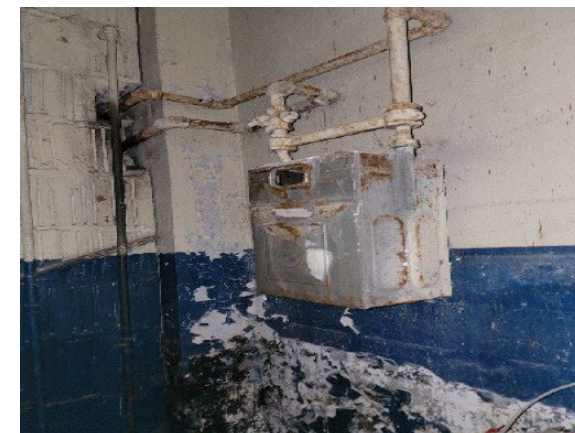
Existing Gas Meter

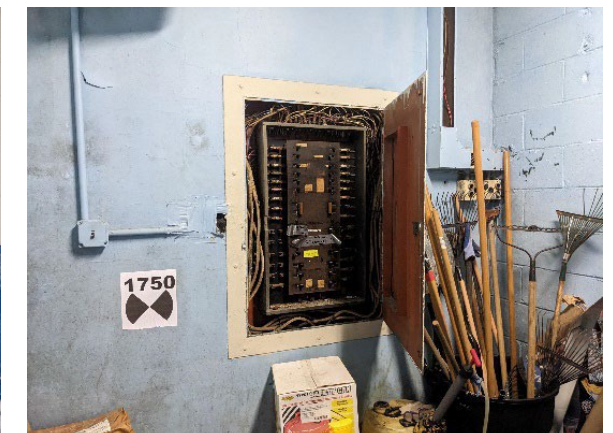
Typical Existing Electrical Panel
