BROADWAY AT VAN CORTLANDT PARK

SAFETY AND MOBILITY IMPROVEMENTS

New York City Department of Transportation

Presented by the Bicycle and Greenway Program on May 25, 2017

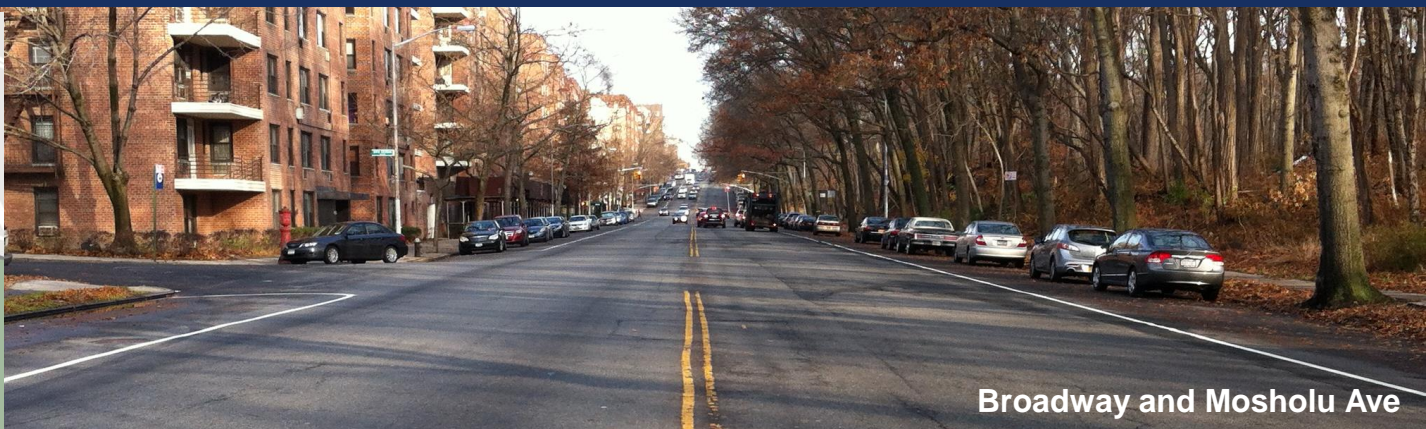
1 – Broadway Corridor: Westchester County to W 246th St

Existing Conditions

- 70' wide roadway
- Moderate traffic volumes during peak hours
- Low off-peak traffic volumes
- Edge condition along park
- Wide parking lanes create space for cyclists, 12hr counts: 260 Sat/150 weekday

Issues

- Speeding, especially during off-peak hours
- Long pedestrian crossings
- Infrequent pedestrian crossings

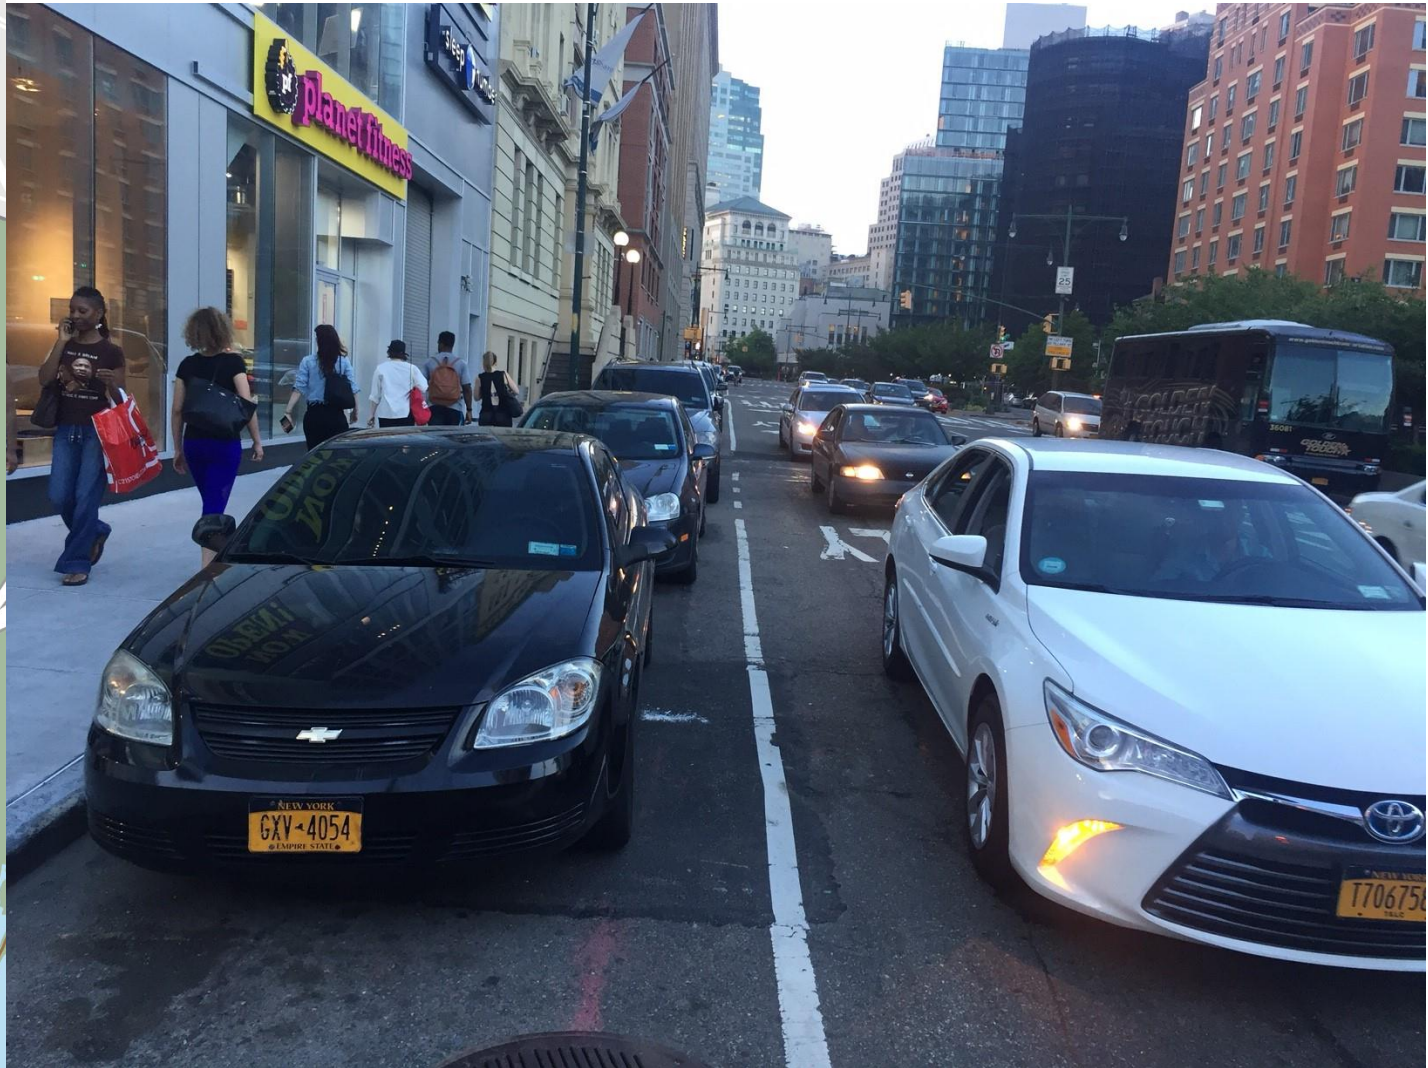
1 – Broadway Corridor: Westchester County to W 246th St

On-street Parking

- 8' parking is a standard width used throughout the city

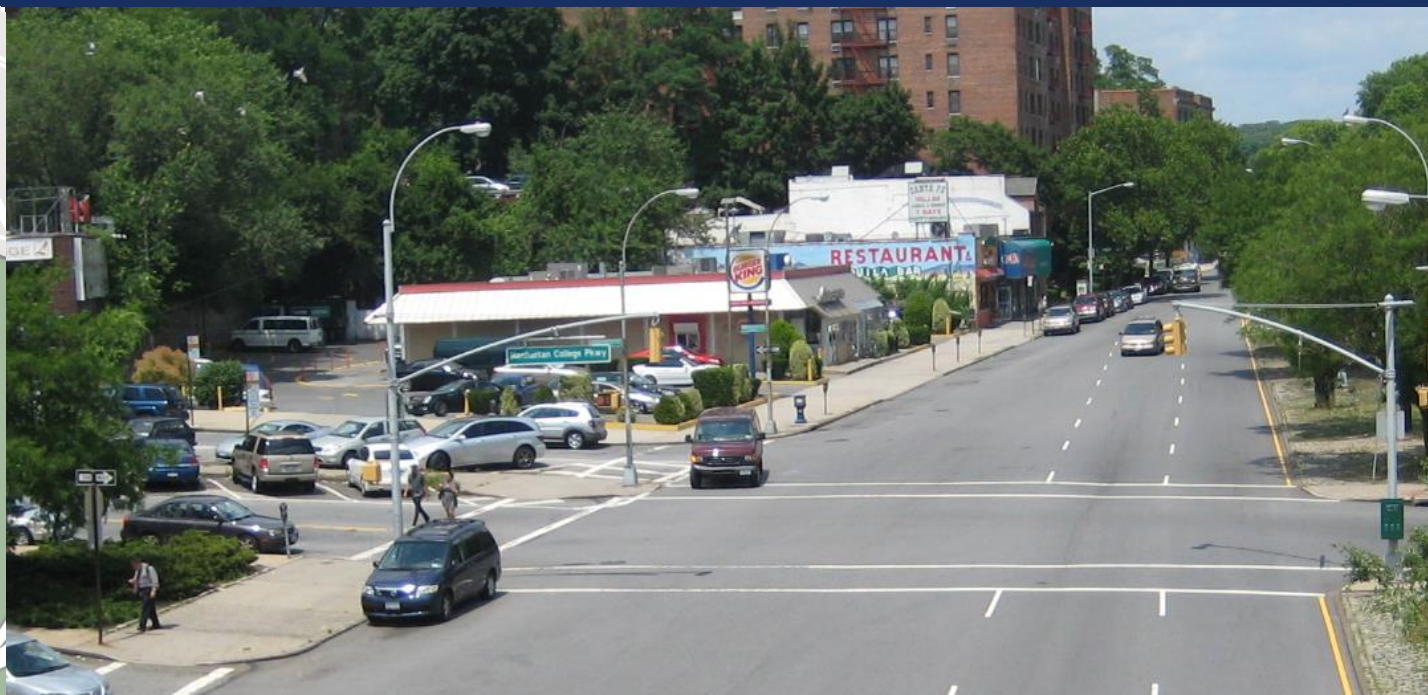
1 – Broadway Corridor: W 246th St to W 242nd St

Existing Conditions

- Land use along both sides of Broadway changes
- Transfers between subway and bus lines
- Roadway widens significantly and includes a median

Issues

- Southbound roadway excessively wide
- Northbound roadway does not have space for protected bike lanes
- Heavy bus loading/unloading on east curb along park

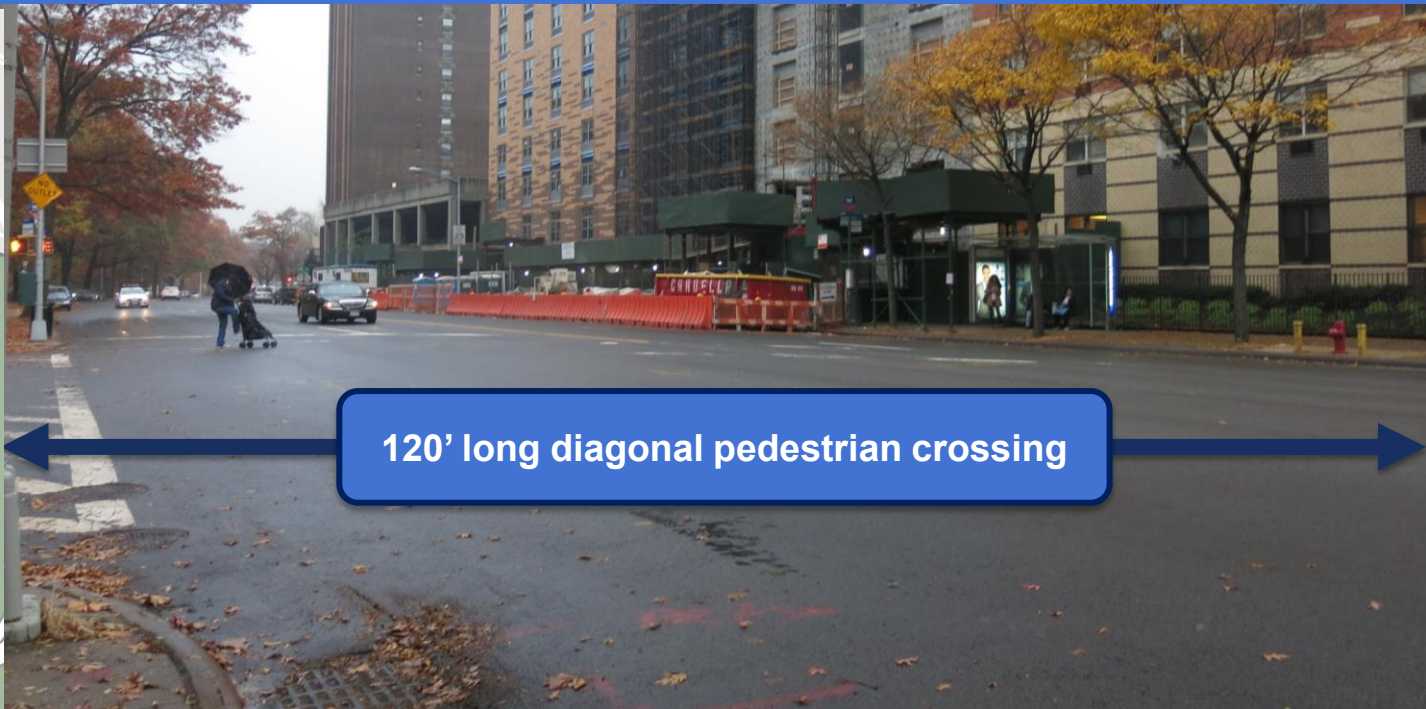
Existing Conditions

- Angled intersection
- Driveway for NYC DOT and DPR vehicles

Issues

- Angle creates very long diagonal pedestrian crossing
- Radius enables vehicles to take very quick turns
- No sidewalks at Sheridan Plaza

Pedestrian fatalities in 2011 and 2012

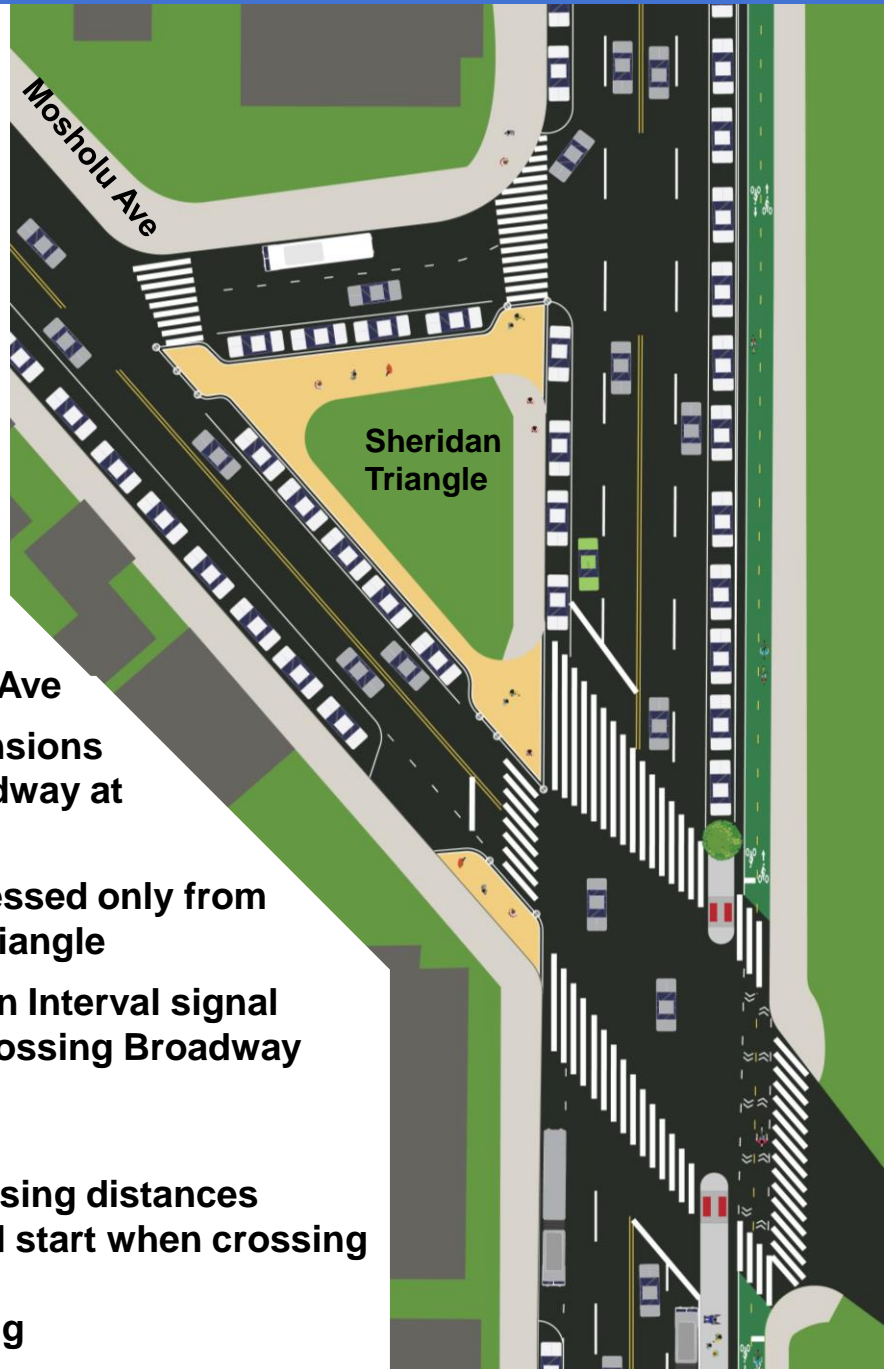
Crossing distance at intersection of Broadway and Mosholu Ave reduced 33% from 120' to 80'

Proposed Design

- Install bus boarding and pedestrian safety islands on the east side of Broadway at Mosholu Ave
- Install painted curb extensions on the west side of Broadway at Mosholu Ave
- Mosholu Ave will be accessed only from north side of Sheridan Triangle
- Install Leading Pedestrian Interval signal timing for pedestrians crossing Broadway

Benefits

- Reduces pedestrian crossing distances
- Gives pedestrians a head start when crossing Broadway
- Maintains existing parking

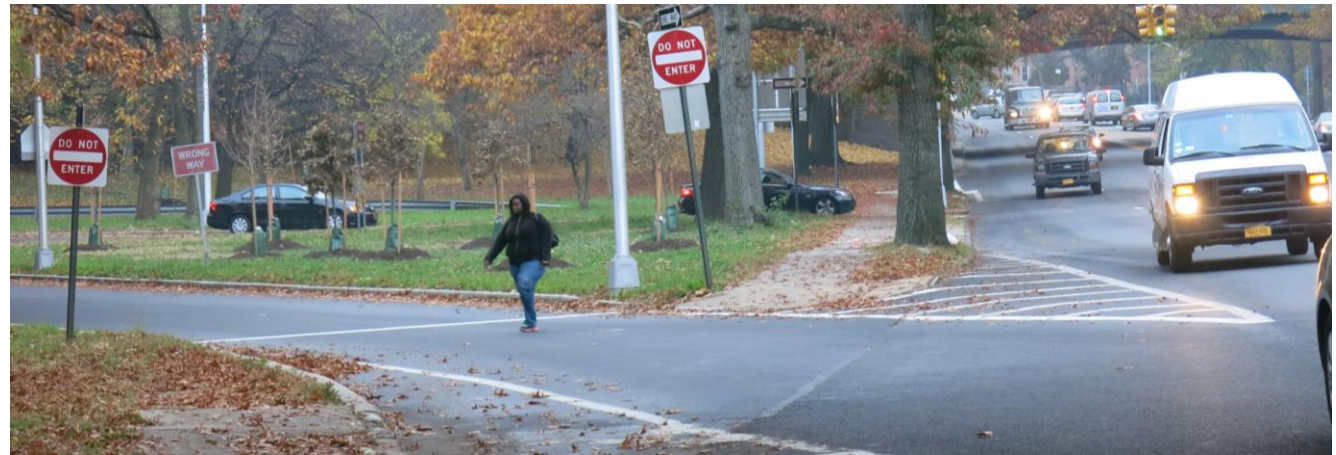
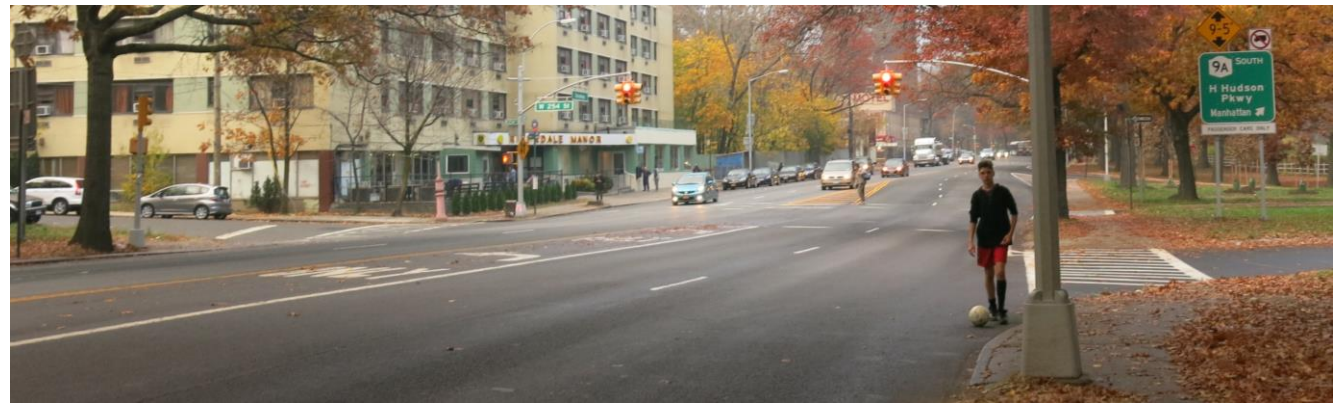
Existing Conditions

- Uncontrolled ramps crossings
- Angle of ramps facilitates fast vehicular movements
- Long distances to cross at ramps and across Broadway

Pedestrian fatality at W 254th St in 2015

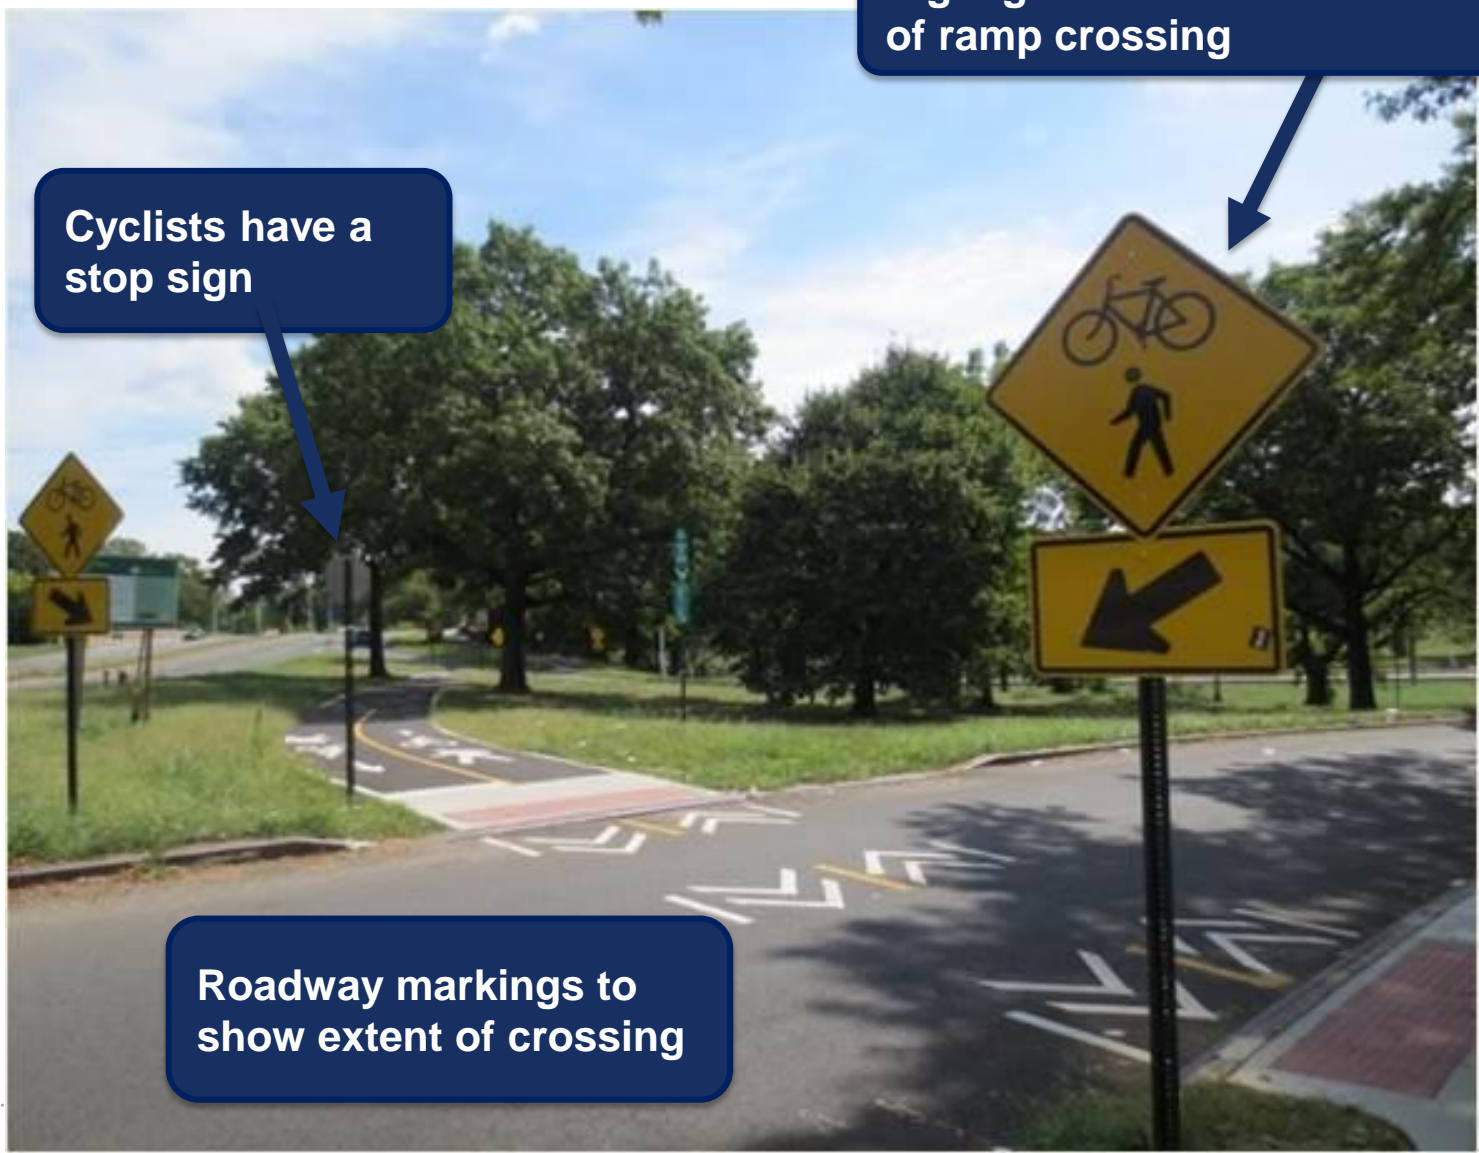
Unsignalized Ramp Crossings

Cyclists have a stop sign

Signage to advise motorists of ramp crossing

Roadway markings to show extent of crossing

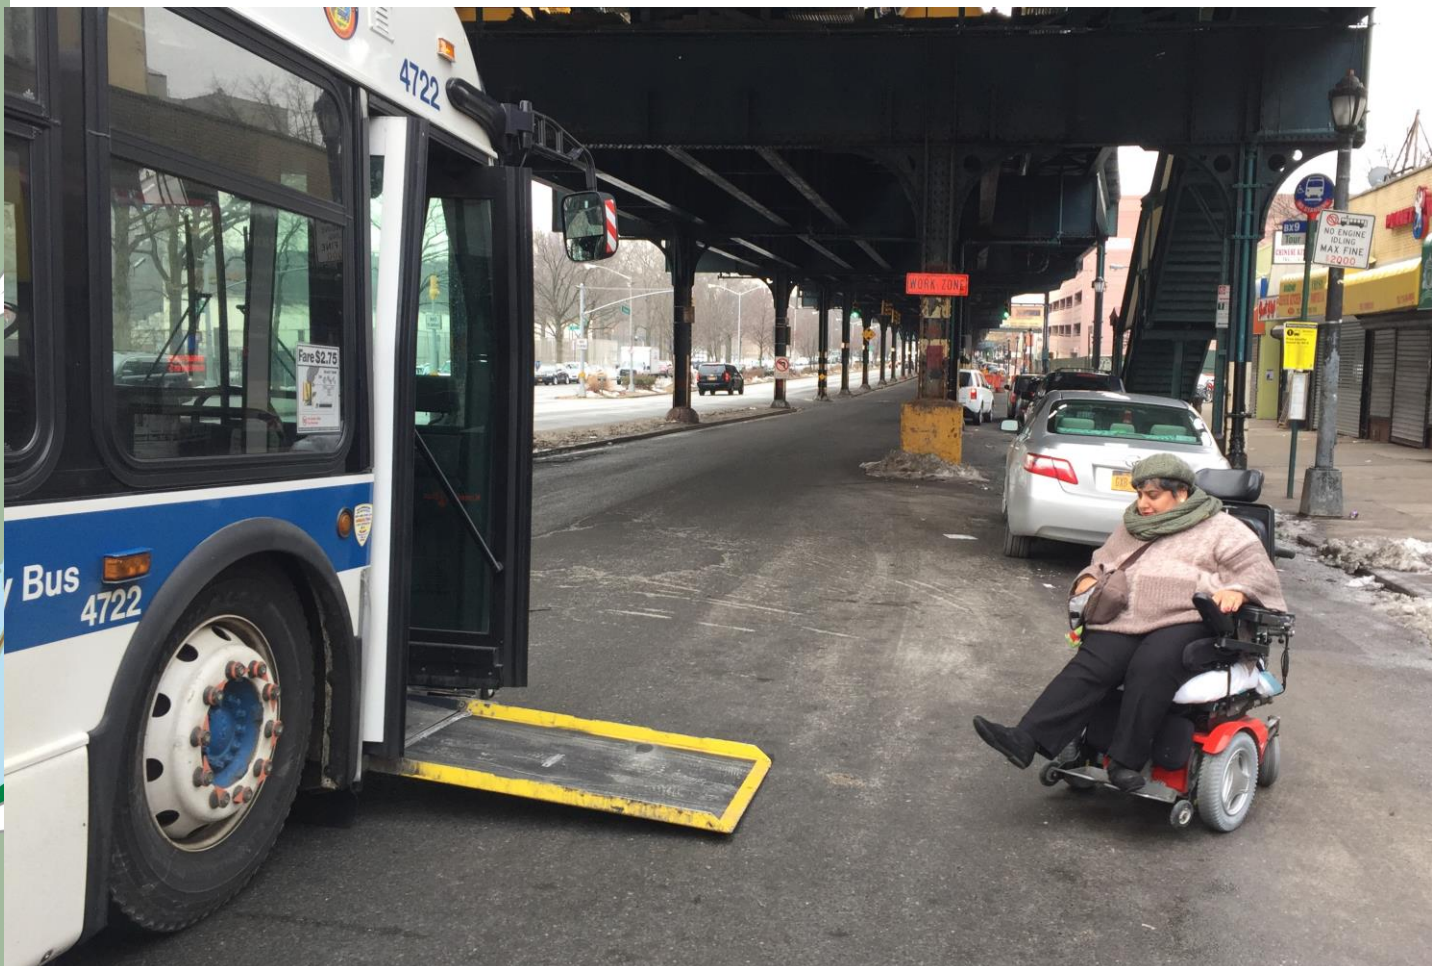
Broadway and Manhattan College Pkwy

Existing Conditions

- Bus stop at elevated train station
- Columns in roadway divide southbound travel lanes

Issues

- Buses regularly do not pull to the curb to drop off/pick up passengers
